State of Utah DEPARTMENT OF NATURAL RESOURCES Division of Oil, Gas & Mining

Inspection Report Minerals Regulatory Program 5/17/2012

Mine Name: Organa Claims	Permit Number: S/055/0013	
Operator Name: Organa Minerals Products Inc.	Inspection Date: May 2, 2012	
Inspector(s): Wayne Western	Time: 3:40 – 4:00 pm	
Other Participants: John Reay, BLM	Mine Status: ACT	
Weather Condition: Warm and sunny	Last Inspection: April 19, 2011	
Bond Renewal Date: NA	Bond Amount: NA	
Surface Ownership: BLM	Mineral Ownership: BLM	
Last Year of Production: none	Acreage: 5 acres

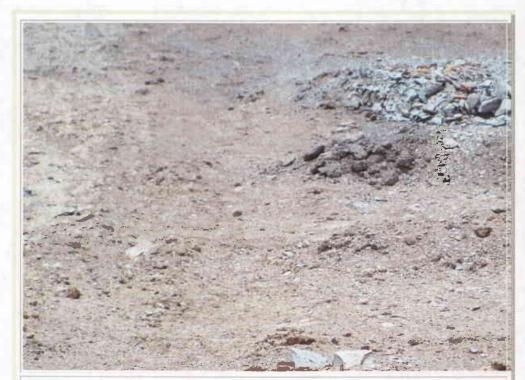
The Division issued a directive for the Permittee to reclaim the site. Upon inspection the Division and the BLM determined that the reclamation done on the site did not meet the minimum requirements for release. The Permittee needs to do additional work to the access to prevent unauthorized access. The piles of rock are insufficient to stop vehicles from entering the site.

Rock piles used to block access are insufficient to prevent access by vehicles.

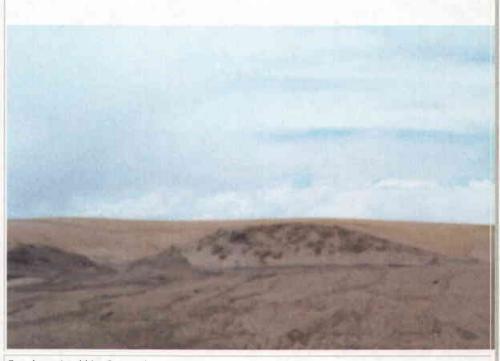
The Permitteee also needs to do some additional grading to eliminate steep slopes on the site.

Cut slope should be flattened.

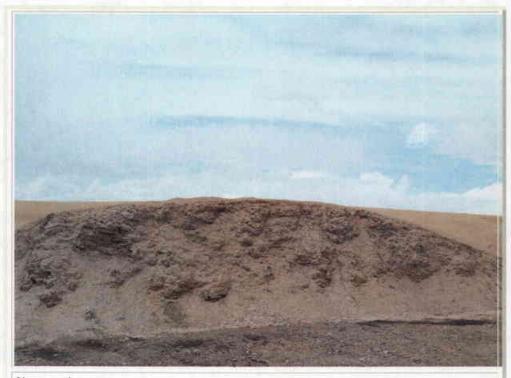
Close up of step cut

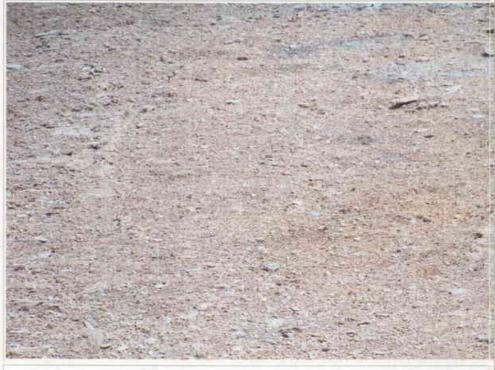
Area has little if any vegetation.
